# Elwha River Dam Removals: A Nearshore Synthesis a Decade After the World's Largest Dam Removal Project

Coastal Watershed Institute (CWI), September 2022 Port Angeles, WA 98362  
[www.coastalwatershedinstitute.org/](http://www.coastalwatershedinstitute.org/) [cwi.general@coastalwatershedinstitute.org](mailto:cwi.general@coastalwatershedinstitute.org)

Coastal Watershed Institute (CWI) 2022. Elwha River Dam Removals: A Nearshore Synthesis a Decade After the World's Largest Dam Removal Project. A CWI Technical Report. Coastal Watershed Institute Port Angeles, Washington. ISSN 092022:1. ISSN2643-9697

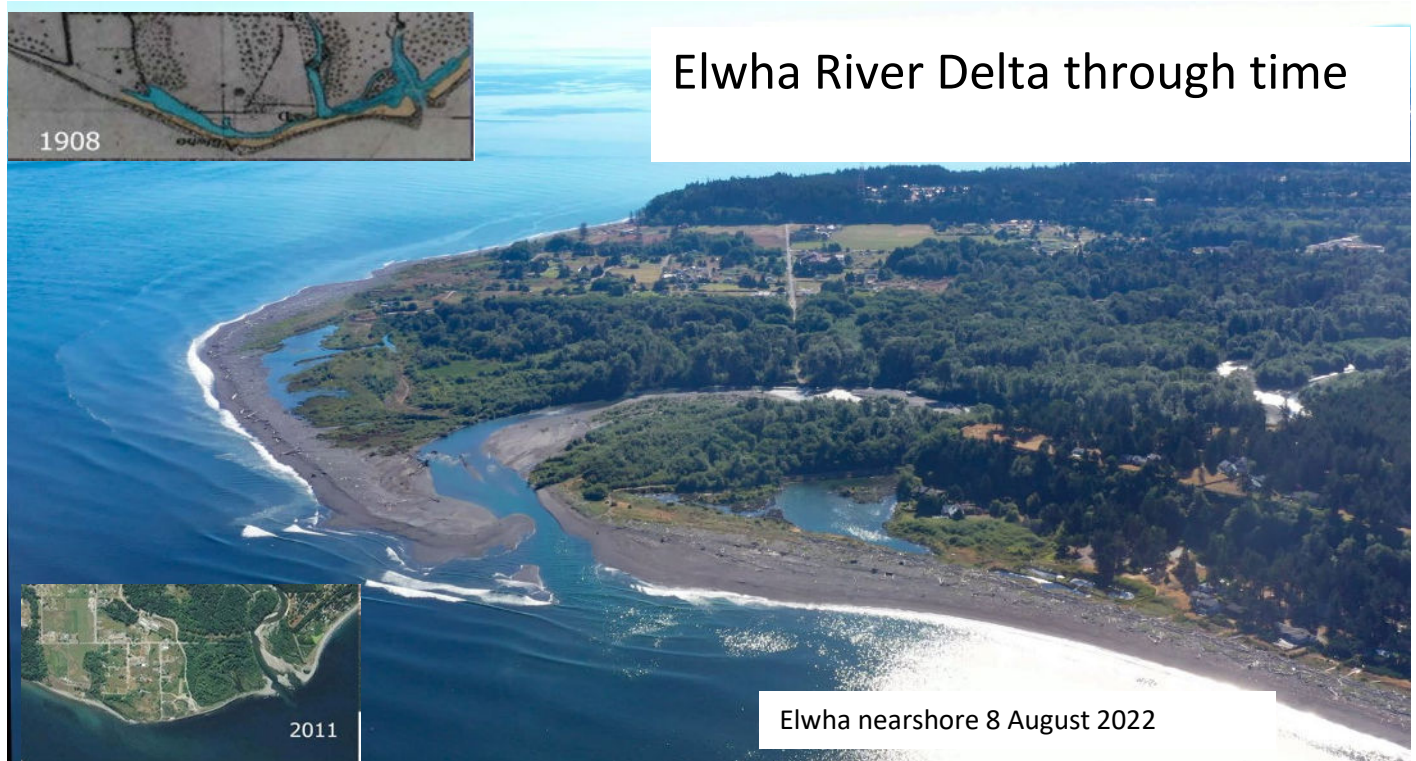
Figure 2. Elwha River Delta in the pre-dam era (1908), the dammed sediment starved era in which the estuary was almost entirely lost (2011) and the post-dam era where the east estuary (left side in 2011 photo) has naturally rebuilt with sediments made available by dam removal, while the lower river and west estuary remain altered by the Place Rd levee.

By 2017 over 2/3 of the sediment stored in the reservoirs was mobilized with 90% of that volume discharged to the coast (Anderson and Hoffman 2017). Since approximately 2019 (five years after dam removal ended) the Elwha system, including the nearshore, has been transitioning to a post-dam removal restoration phase. The east delta shoreline spit and lagoon complex are similar to that mapped on the 1908 GLO T-sheets (PNPTC, 2006, Figure 2).

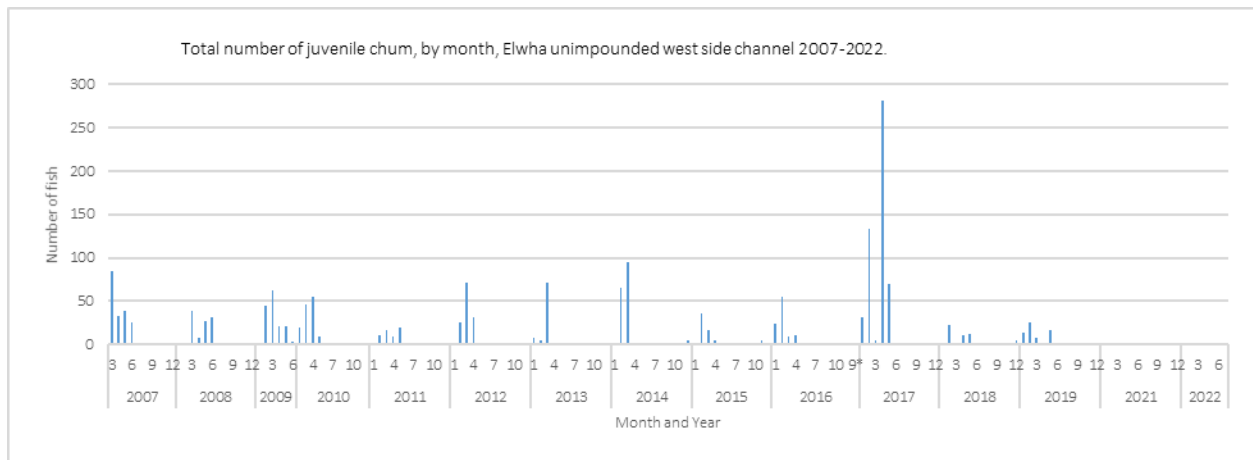
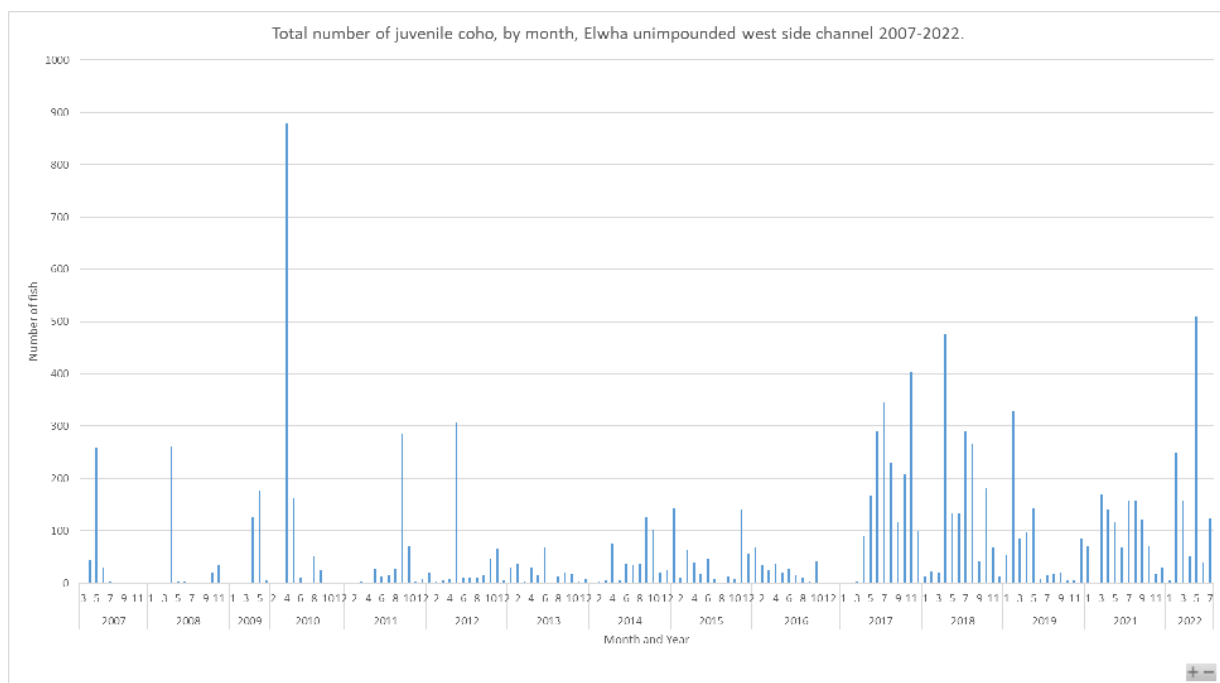
Figure 3. Juvenile Coho and Chum use of the Elwha unimpounded west side channel 2007-2022. Note no sampling occurred from 3/2020-01/2021 due to Covid.

Since 2019, salmon use of the unimpounded Elwha west estuary has transitioned primarily to Chinook (*Onchoryncus tshawyscha*) and Coho. Juvenile Coho continue to use the site heavily for overwintering (Figure 3). Juvenile Chum salmon numbers have continued to decline over the last decade. When dam removals began hundreds of juvenile Chum were observed annually from January to June in the Elwha west side channel. In 2021, only single digit migrating Chum were observed (Figure 3, Shaffer et al., in review). This is troublesome as Pink (*Onchoryncus gorbuscha*) and Chum salmon were the two most abundant salmon in the Elwha system prior to construction of the in river dams.

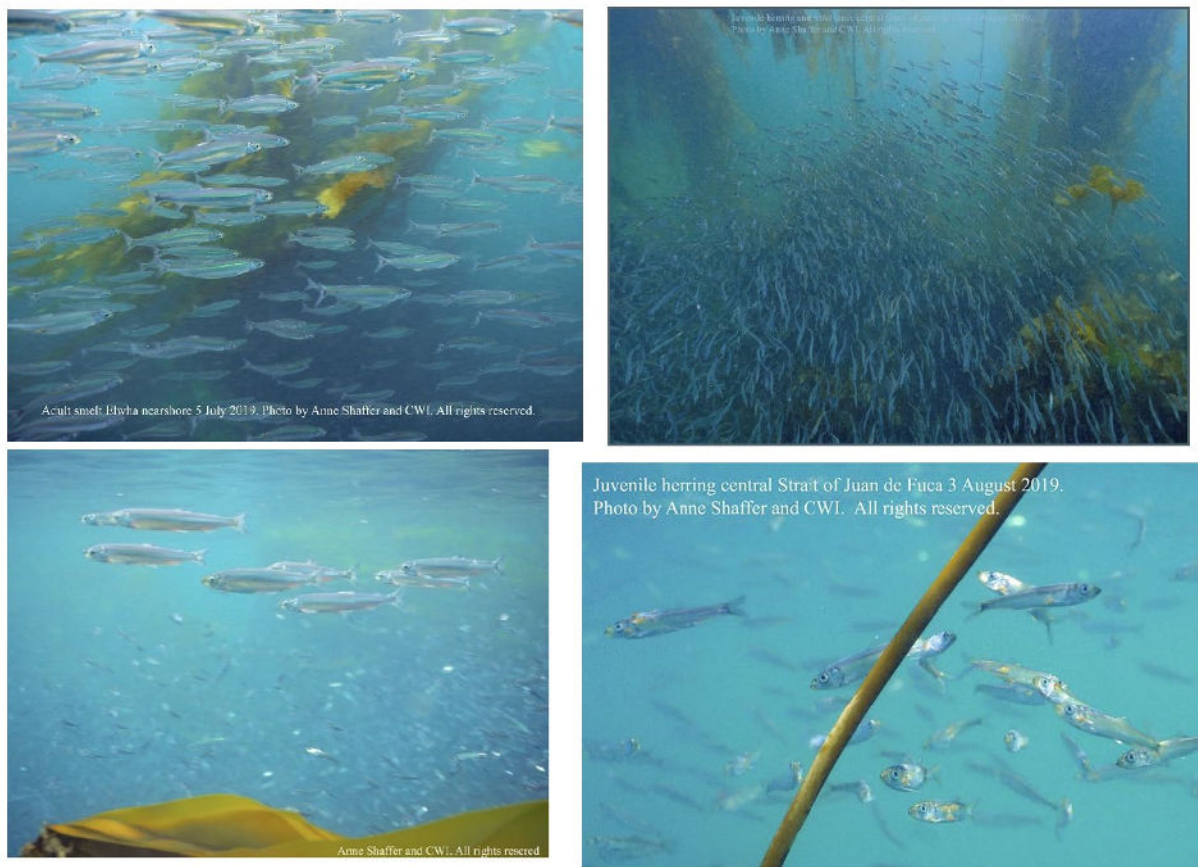
Figure 4. Typical images of juvenile and adult surf smelt, sand lance, and herring, Elwha nearshore 2019. (Shaffer 2019). Photos provided with permission of author.

Forage fish continue to be the dominant guild of fish using the Elwha shorelines (Frick et al 2022). Juvenile and adult forage fish abundance have increased significantly in the last five years, which we attribute in part to shoreline ecosystem restoration (see below) (Figure 4, Shaffer et al 2019)

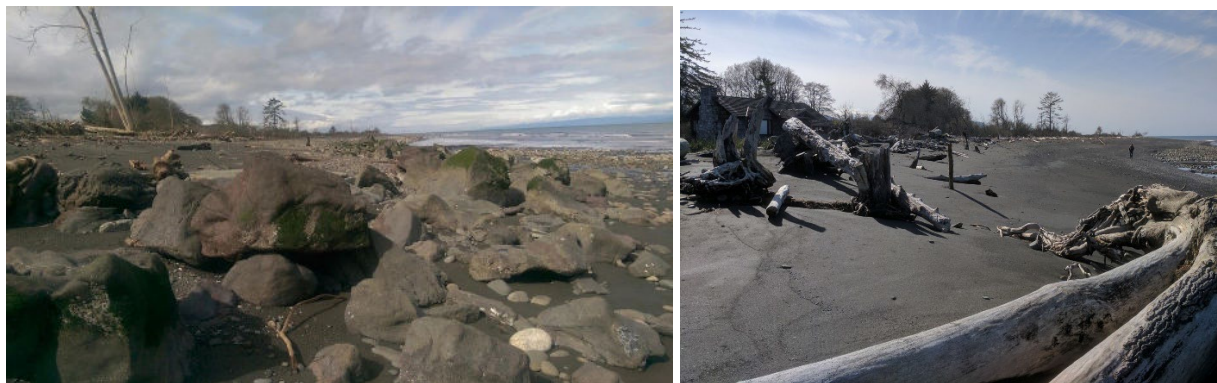
Figure 5. Elwha east delta before and after shoreline armor removal

East Elwha delta. At the 2015 Elwha Nearshore Consortium (ENC) workshop, it was discovered that ~1,200 m of derelict intertidal armor ~1,600 m east of the river's mouth was inhibiting the natural rebuild of the beach as a result of the armor interrupting natural sediment and large woody debris transport and deposition processes (ENC 2015). A restoration project was developed and implemented by CWI and partners to remove the 8,400 m<sup>3</sup> of 2-3 meter diameter rip rap and 11 m<sup>2</sup> concrete panels (from the beach at tidal elevations between -1 and +3 meters MLLW). Removal of the shoreline armoring resulted in an immediate natural process rebuild of intertidal beach in the project footprint (Figure 5). Along the east delta and feeder bluff reaches of the Elwha nearshore, the buildout of a sandy/gravelly upper intertidal beach increased beach wrack and invertebrates density and expanded

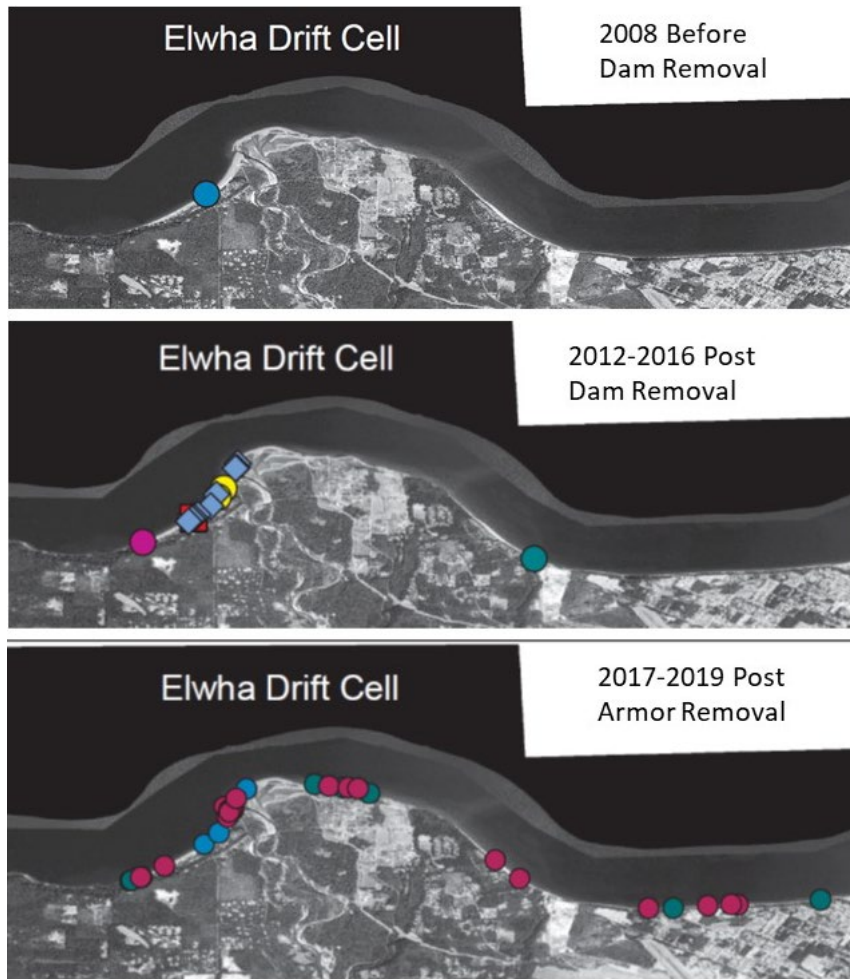
Figure 6. Results of long term monitoring of forage fish spawning of the Elwha drift cell. Surf smelt spawn range extension post dam removal and shoreline armor removal. Symbols indicate egg location by dam removal stage. Data from Shaffer and CWI.

the range of surf smelt spawning (Figure 6), and the ecological community quickly ‘caught up’ to those of non-armored Elwha shorelines (Shaffer et al., In Review). Ecological and physical benefits of the removal of sediment transport impediments have been observed not only at the restoration site, but also extend throughout the remaining ~10 km of the east drift cell in broader, sandier beaches (Figure 7).

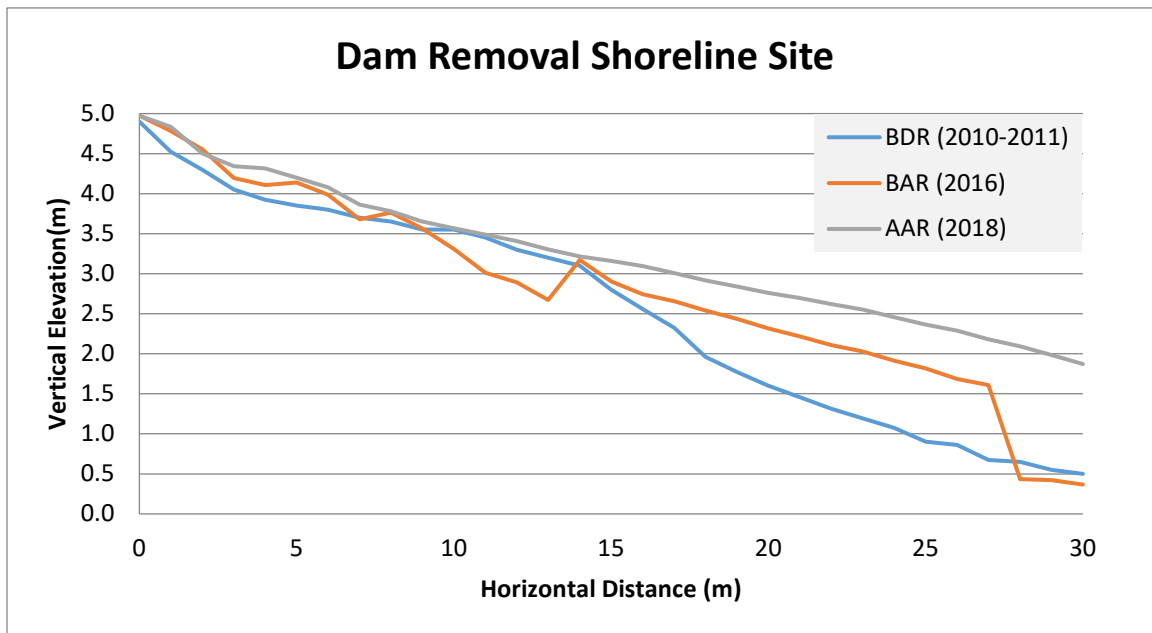
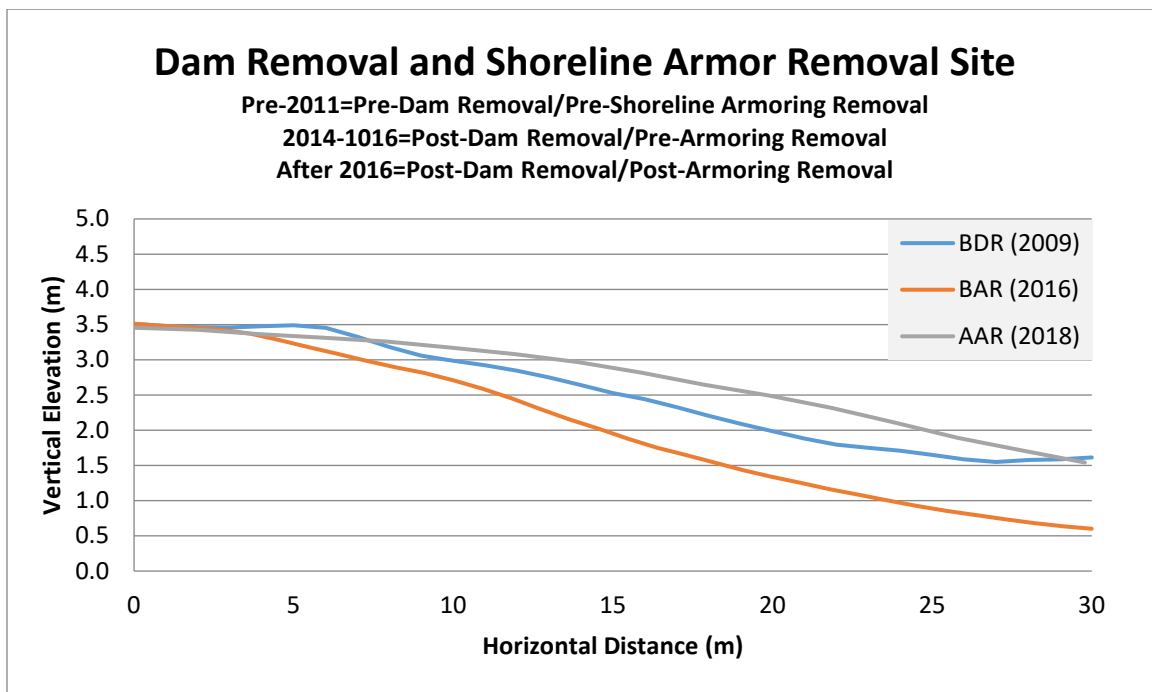
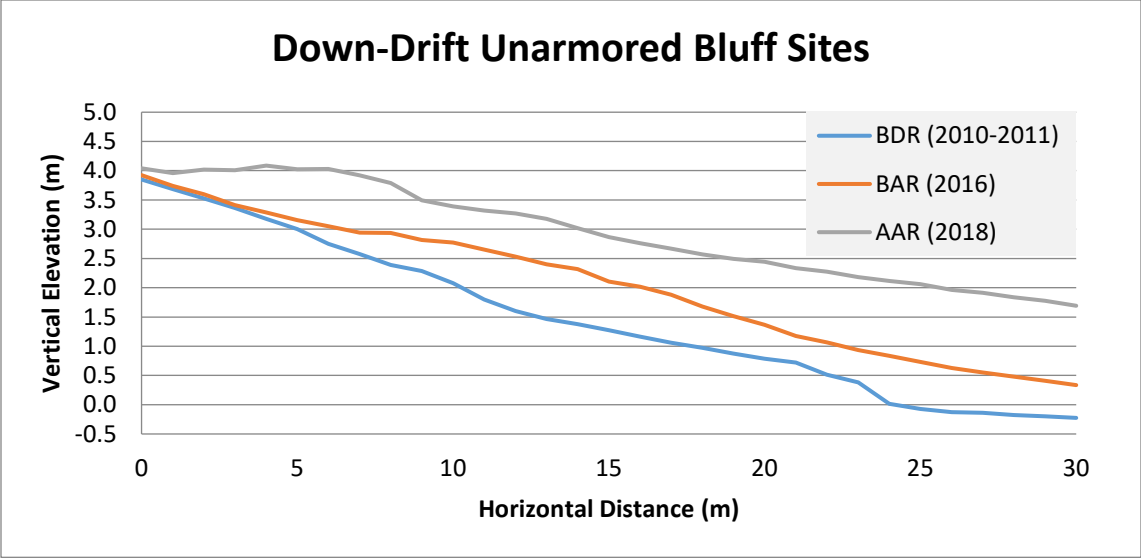
Figure 7. Beach profiles Elwha west, east, and down-drift unarmored bluff shorelines-A. dam removal shoreline site) (BDR= pre 2011=pre-dam removal/pre-shoreline armoring removal; BAR=2016=post-dam removal/ pre-armoring removal; AAR=2018 =post-dam removal/post armoring removal. Graphs reprinted with permission from Shaffer et al (in review).
