David S. Parks (dave.parks@ecy.wa.gov)
Coastal Watershed Institute/Ecology
Introduction

Beach Morphology and Grain-Size Distributions in the Elwha and Dungeness Drift Cells: Before, During, & After Elwha Dam Removals, 2010-2022.

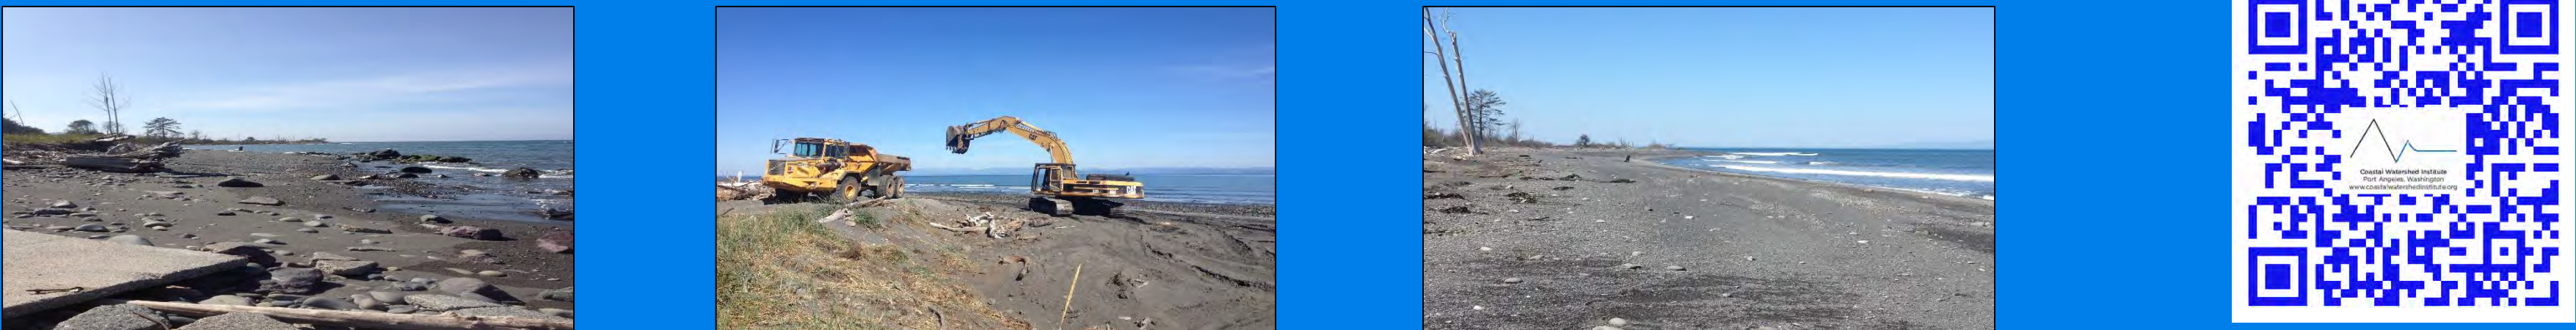
2016-2017 East Elwha Delta Armor Removal-CWI

In 2016-2017, The Coastal Watershed Institute removed approximately 8,400 m³ of large riprap (shoreline armor) from over 1200 m of the armored Elwha River east delta, restoring the hydro-dynamics of the eastern delta intertidal beach (Shaffer et al. 2022, In Review).

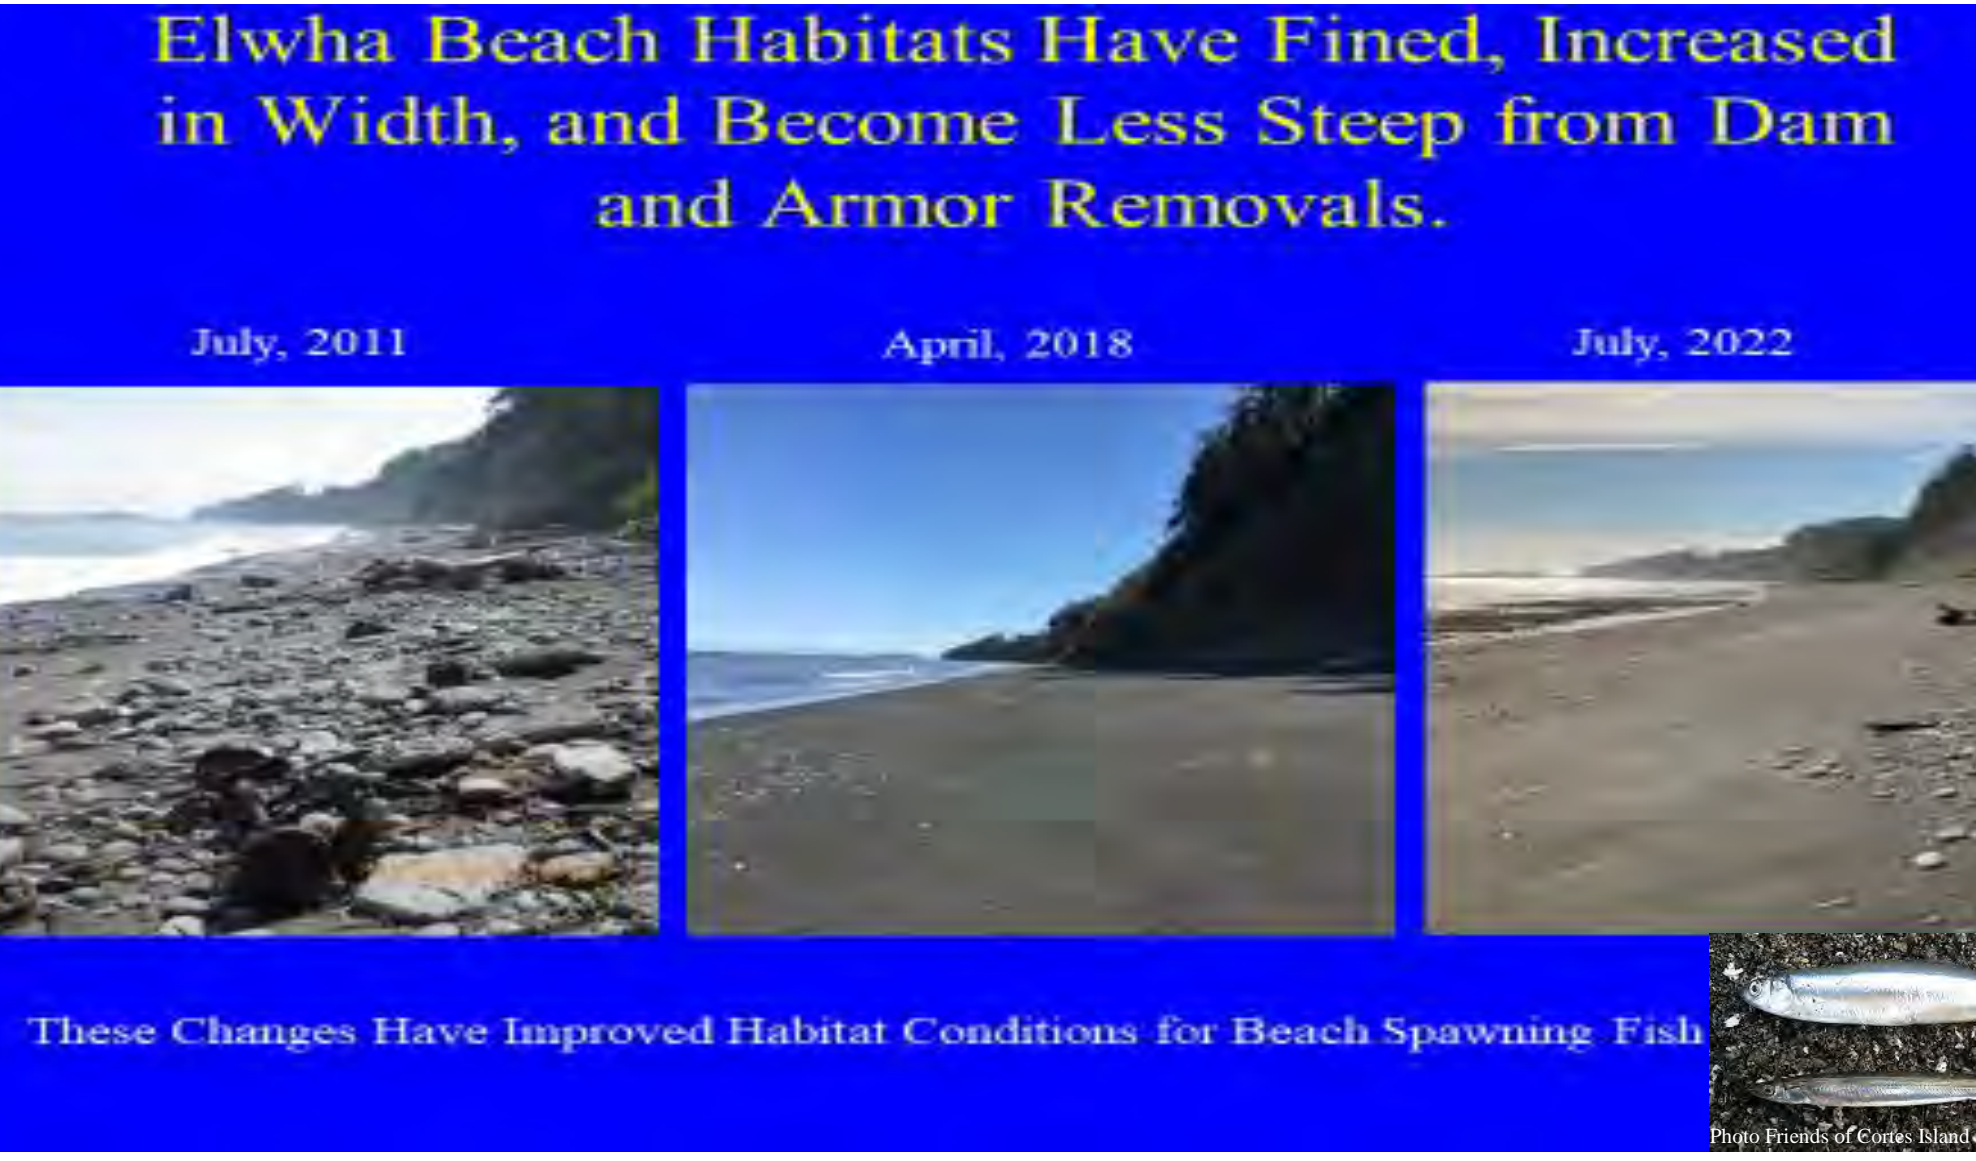
Topographic Change Elwha Dungeness

Elwha transects displayed positive elevation change (aggradation) post-dam and post-armor removal compared with Dungeness Transects which displayed erosional trends during and after dam and armor removal.
